Preface

Design concept

Test Report on Non-Return Valve for Water Closets

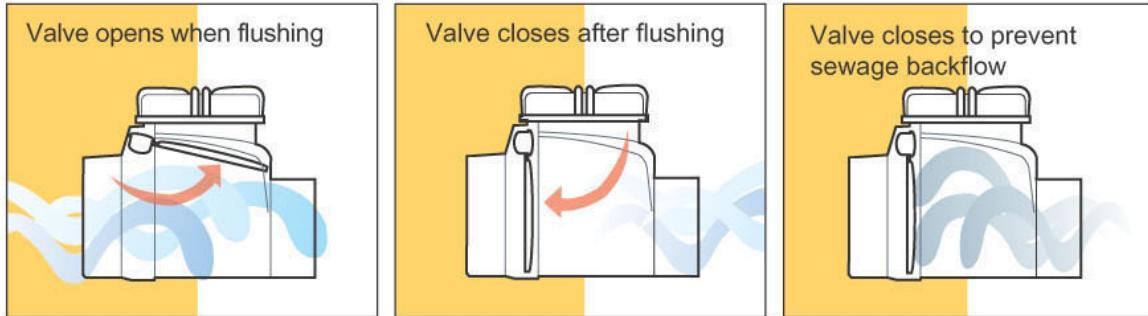
- A** Unibody base designed for precise construction of Poseidon Non-return Valve
- B** Double rib gasket provides better air/water seal and arched flapper enhances water flow
- C** Weight activitated Mechanism (W.A.M.) designed to enhance water flow
- D** Two 50mm stacks are reserved for vent/drain pipe installation
- E** The outlet is designed with male connection for installation in narrow spaces
- F** Double thread design is easy and quick to operate

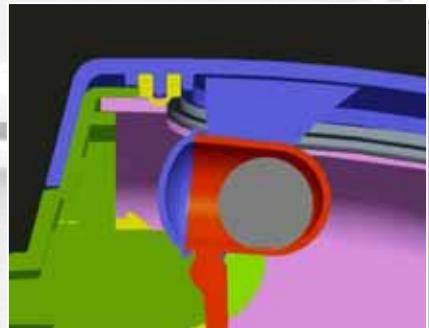
Traditional non-return valve uses a dead weight flapper which may severely impacted the water flow. Poseidon® patented Weight Activated Mechanism (W.A.M.) is designed to reduce the weight of the flapper when it opens and exerts less resistance on water flow.

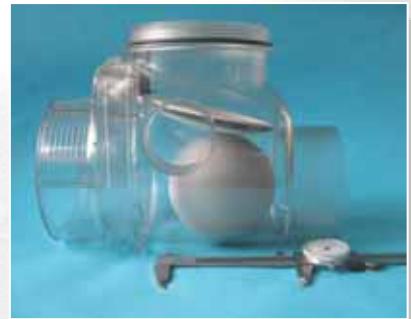
Poseidon® non-return valve may be the first uPVC non-return valve in the world to have two pre-built stacks reserved for vent or drainage pipe installation. This design may also save cost because no extra fitting is necessary.

Poseidon® Sk-9000 has an open angle of over 90° degree and passes BS 4514 Ball Passing Test with a 100mm spheroid, where a 95mm spheroid is required to pass the fitting.

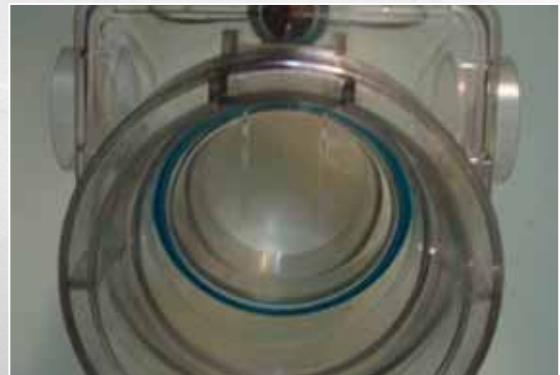
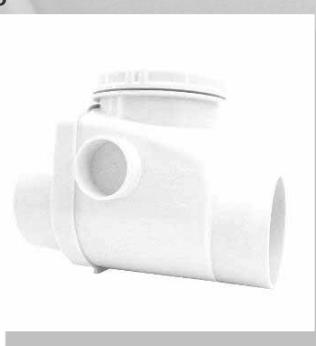
Poseidon® non-return valve is equipped with Double Rib Gasket on the flapper, which is superb in air/water seal. It is tested to block 99% of gas penetration by HKU. The shape of the flapper is arched which provides superior flow characteristic. Traditional non-return valves may not even have a gasket and most of them use a flat flapper design.

The outlet connection of Poseidon® Sk-9000 is male, unlike tradition female design, which requires longer connection spaces. In addition, the access cap is specially designed to open and close easily and quickly.

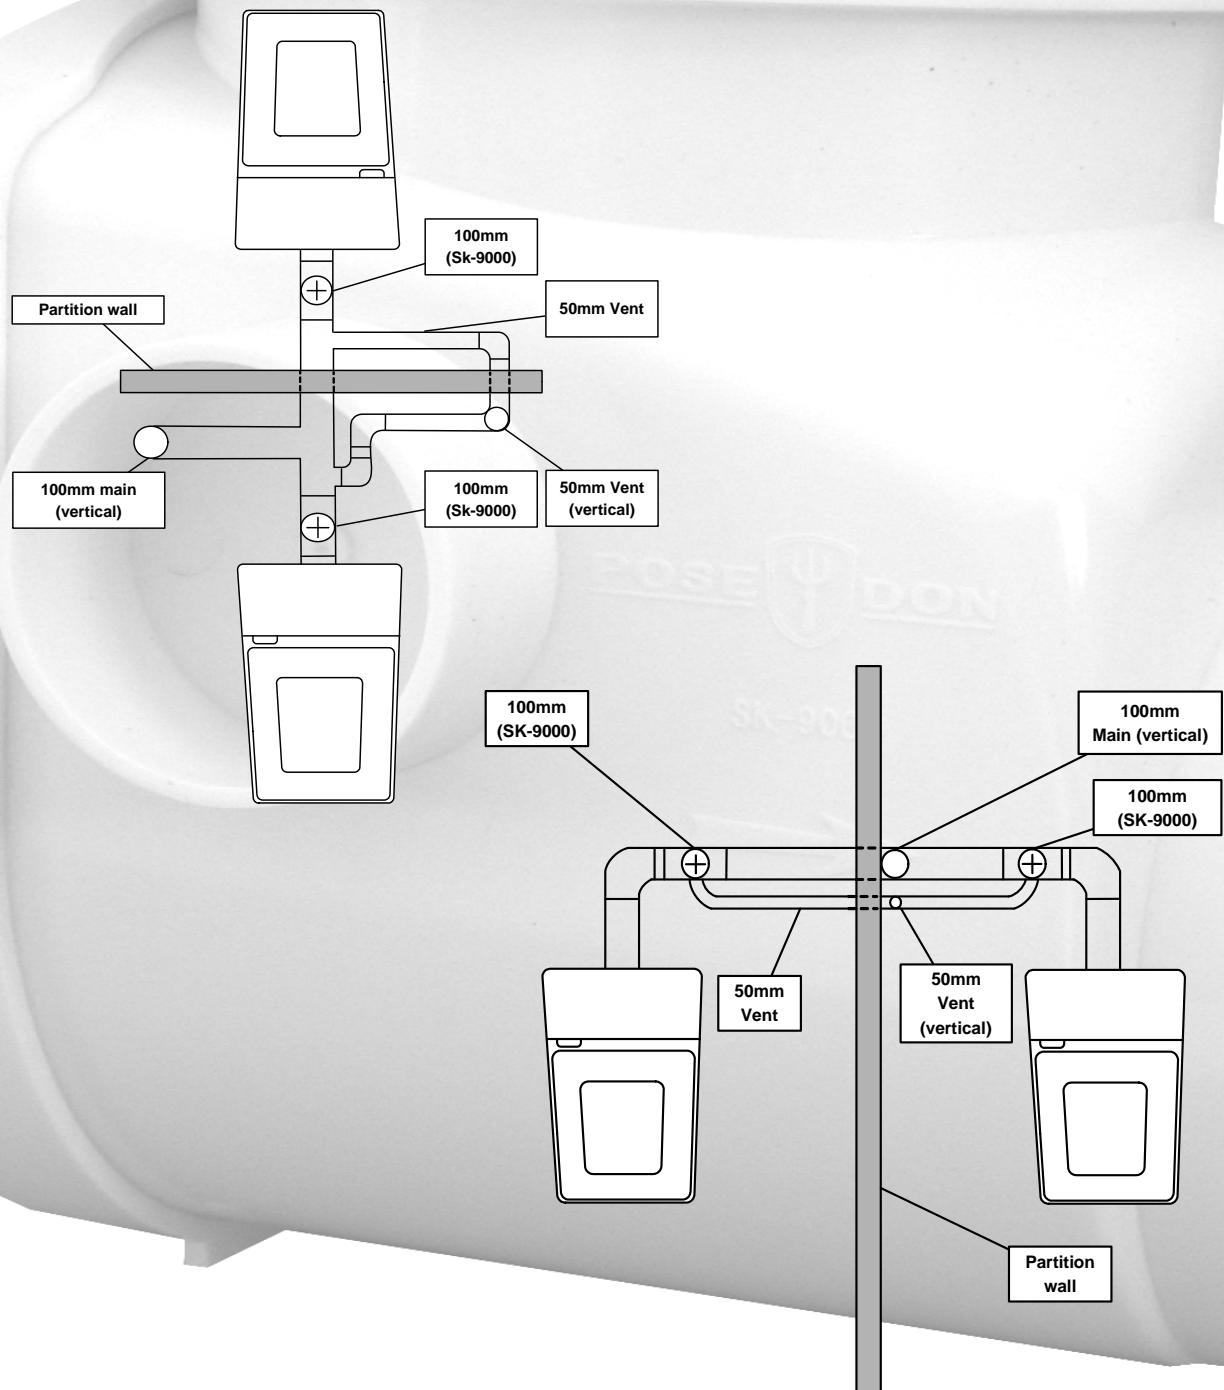
Sample Installation Diagrams

Two lavatories sharing one drainage pipe (Common Discharge):
Poseidon® non-return-valve can prevent sewage backflow from neighboring pipe.

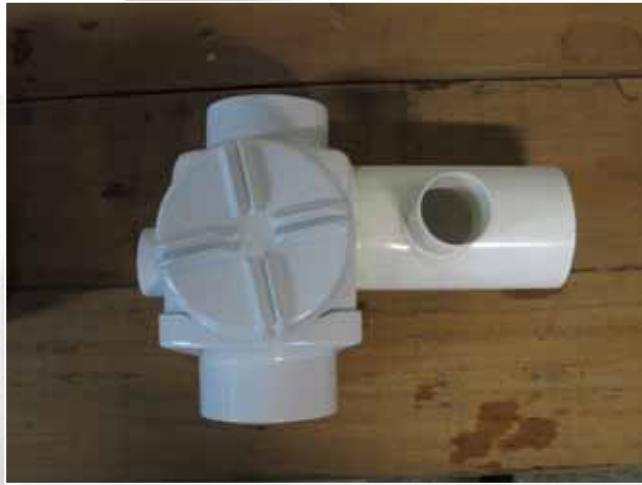
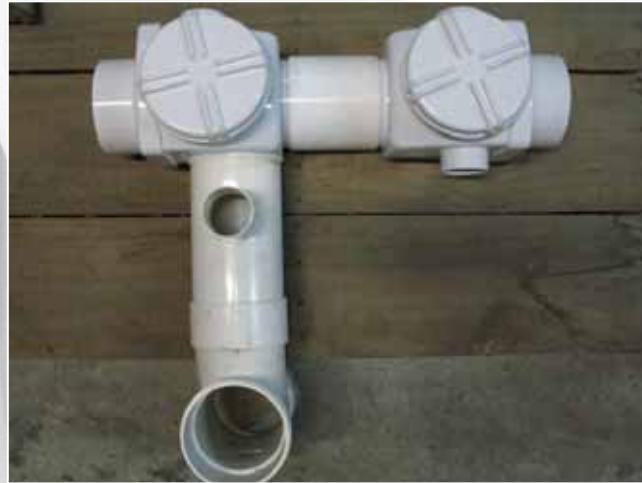
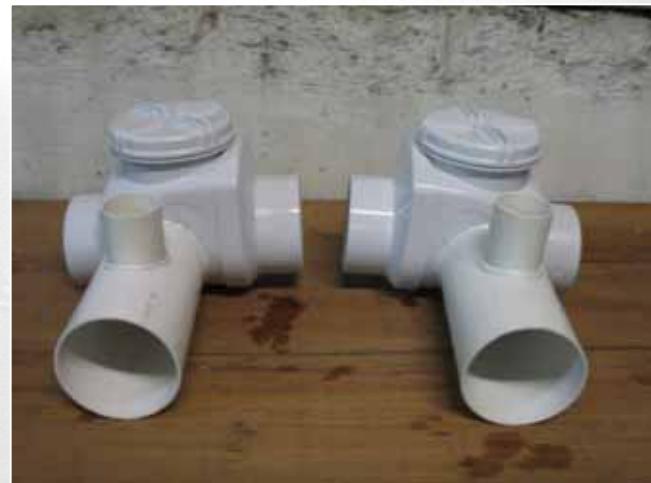
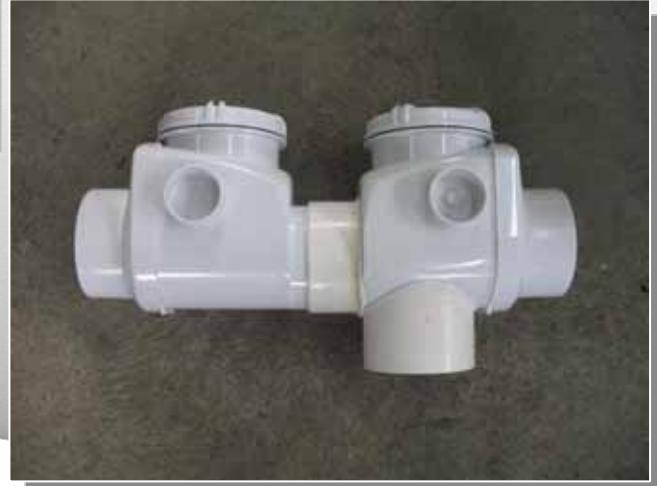
Custom-made Solutions

East Wind Products Limited can offer custom-made Non-return Valves (NRV) for our clients. Please contact us for details.

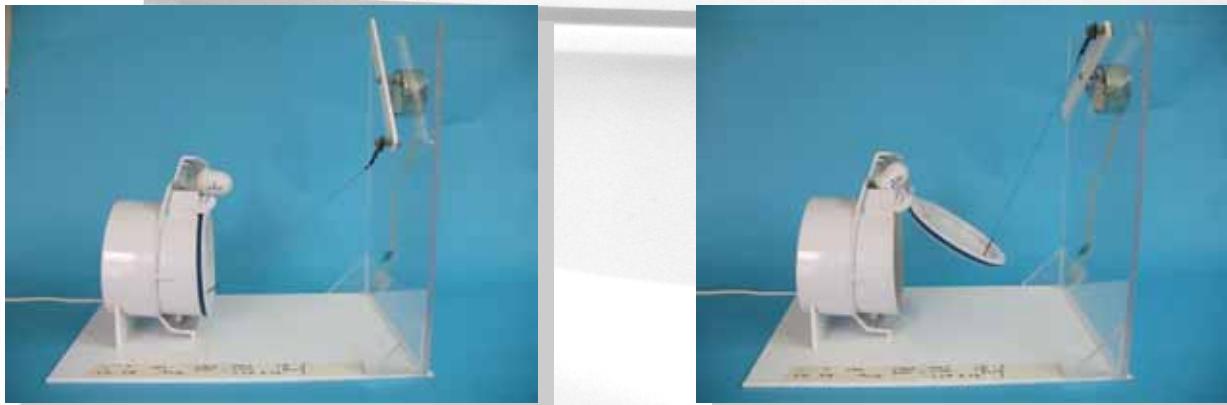
Hinge Durability Report

The purpose of this test is to investigate the durability of the hinges of Poseidon non-return valve. Hinge durability is measured by the amount of deterioration of hinges diameter after 100 hours of continuous operation. A testing apparatus is setup to operate an open and close cycle of the hinges of Poseidon non-return valve 33 times per minute.

Total number of cycles the hinges were opened and closed: (33 times/minute) X (60minutes/Hour) X (100 Hours) = 198,000 cycles.

Before test	Left hinge	Right hinge
	4.94	4.90
After test	Left hinge	Right hinge
	4.86	4.84

After 100 hours of continuous open and close cycles of Poseidon non-return valve. The hinges diameter deteriorated 1.6% and 1.2% respectively. This test result suggests minimum deterioration of hinge diameter even after 10 years of operation.

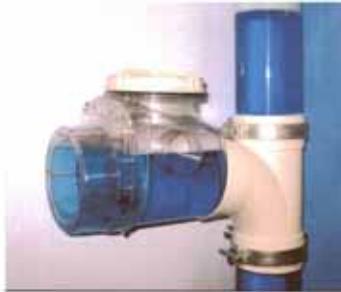
Figure 2. Setup for Leakage Test

A water head was applied to the flap of the non-return valve in the inverted flow direction as shown in Figure 2. The leakage rate at different levels of water head were determined using direct measurement of the volume of water leaked out against the time taken.

The leakage test results were shown in Table 1.

Water Head against Flap in Reverse Flow Direction (mm Water)	Leakage Rate (ml/s*)
147	0.54
120	2.07
100	4.89
80	6.47
30	6.47

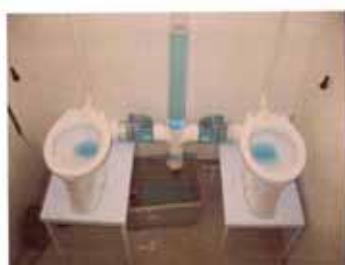
Figure 3. Setup for Flow Characteristics Test

Four water closets were each fitted with a non-return valve and arranged to have a common discharge connection to the drain stack as shown in Figure 3. High-level columns were installed to provide the source of flushing water. A submersible water pump placed in the water closet bowl was used to draw water from the high-level column. The comparison of flow characteristics for water closets flushing between water with and without non-return valves was made by keeping the flap intact and removing the flap respectively. The highest level reached by the water in the bottommost drain was measured and the time taken for the water to reach the maximum height was measured. The flushing characteristics involving solid water were observed by adding into the w.c. bowl 2 kg. instant sheet length, each about 28 mm diameter and 50 mm long prior to the flushing action as shown in Figure 4.

Item	Non-Return Valve TEST Installed (Flap Removed)	Non-Return Valve Installed (Flap Inserted)
Impacting of Water in Closet for W.C. Flushing	Complete	Complete
Highest Water Level in Horizontal Drains for W.C. (Offset mm)	34	42
Maximum Flap Opening to the Horizontal (Degree)	Not Applicable	61.21
Percentage of Total Water Flushed through W.C. (Assume for 1 hole, a toilet seat less than 100 mm, a toilet seat 28-mm diameter and 30-mm long)	100%	100%

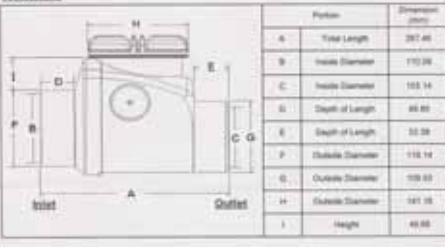
<table border="1"> <thead> <tr> <th>Part</th> <th>Dimension (mm)</th> </tr> </thead> <tbody> <tr> <td>A</td> <td>Total Length</td> <td>287.46</td> </tr> <tr> <td>B</td> <td>Inlet Diameter</td> <td>110.06</td> </tr> <tr> <td>C</td> <td>Inlet Diameter</td> <td>103.14</td> </tr> <tr> <td>D</td> <td>Depth of Length</td> <td>49.85</td> </tr> <tr> <td>E</td> <td>Depth of Length</td> <td>33.38</td> </tr> <tr> <td>F</td> <td>Outlet Diameter</td> <td>110.14</td> </tr> <tr> <td>G</td> <td>Outlet Diameter</td> <td>103.03</td> </tr> <tr> <td>H</td> <td>Outlet Diameter</td> <td>101.16</td> </tr> <tr> <td>I</td> <td>Height</td> <td>49.65</td> </tr> </tbody> </table>						Part	Dimension (mm)	A	Total Length	287.46	B	Inlet Diameter	110.06	C	Inlet Diameter	103.14	D	Depth of Length	49.85	E	Depth of Length	33.38	F	Outlet Diameter	110.14	G	Outlet Diameter	103.03	H	Outlet Diameter	101.16	I	Height	49.65

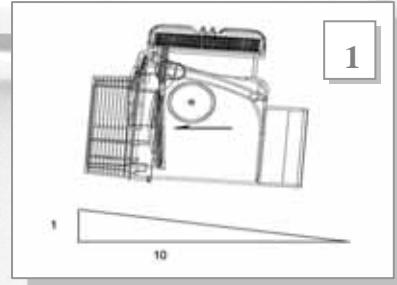
1. Poseidon® Sk-9000 non-return valve is designed to remain closed when situated up to 1: 10 grade.

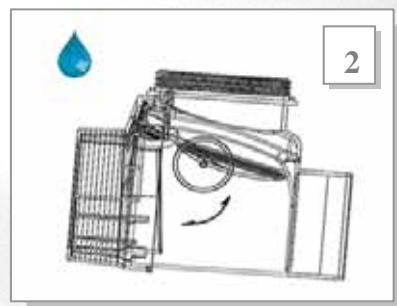
2. Clean and dry all connection areas, be sure that all foreign objects and PVC shreds (from sawing) are removed. Apply appropriate amount of solvent cement and attach pipe to fitting. Depending on the geographical location of the installation, different type/grade of solvent cement should be applied professionally to ensure the connection will withstand the environment. After the connection is made, it is very important that the installer verifies that no solvent cement or foreign object remains inside the valve, and the flapper has a free range of movement as intended.

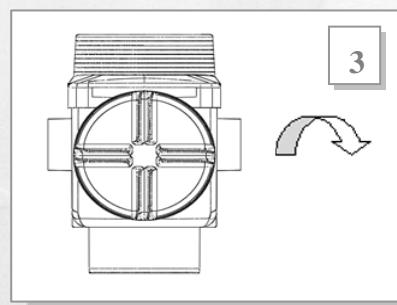
3. Close the access cap and turn clockwise by hand to tighten the access cap. Please do not use any tools to tighten the access cap.

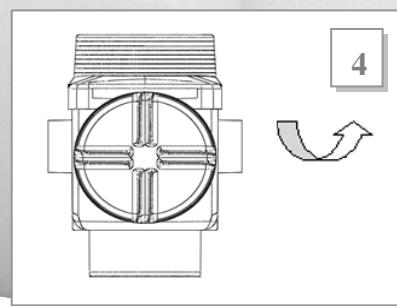
4. To open the access cap, simply insert a screwdriver between the grooves on the access cap and turn counterclockwise.
